**MUJARRAH CANAL BRIDGE
RAMADI, IRAQ**

**SIGIR PA-09-170
JULY 14, 2009**

Mujarrah Canal Bridge

Summary of Report: PA-09-170

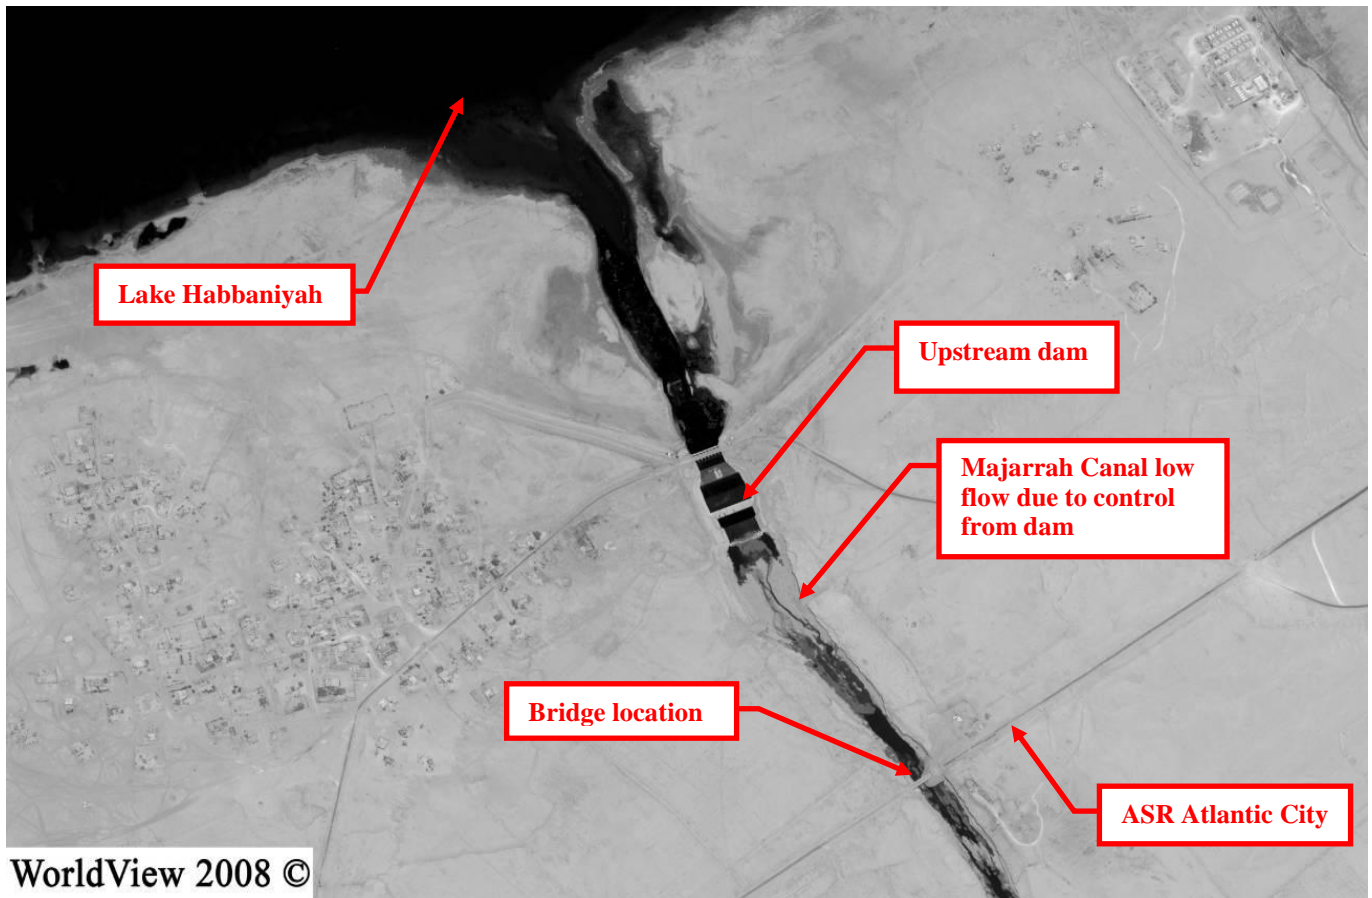
In the confluence of the canal and Lake Habbaniyah, a dam appears to control flows into the canal (Figure 1). GRC Falluja Resident Office representatives did not know if there is potential for a rapid release of storage from the dam; however, the span and under-clearance of the structure appear to permit unimpeded flow in the channel.

Figure 1. Location of Murrarrah Canal Bridge, dam, and Lake Habbaniyah (Courtesy of GRC)
